Preventing flip-chip solder joint failures

[High-Density Interconnect]

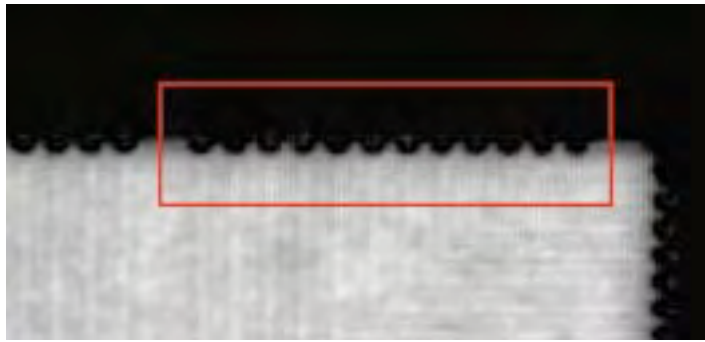
Figure 1: Acoustic image of one corner of a test chip before thermal cycling. Solder joint bonds are dark and it merges into the background since there are no fractures.

All of the solder bump bonds are dark, indicating low contrast and therefore good bonding. After 772 thermal cycles, several solder bumps in the acoustic image of the test chip have become much brighter. These bumps display varying degrees of brightness that correspond to the area of the crack

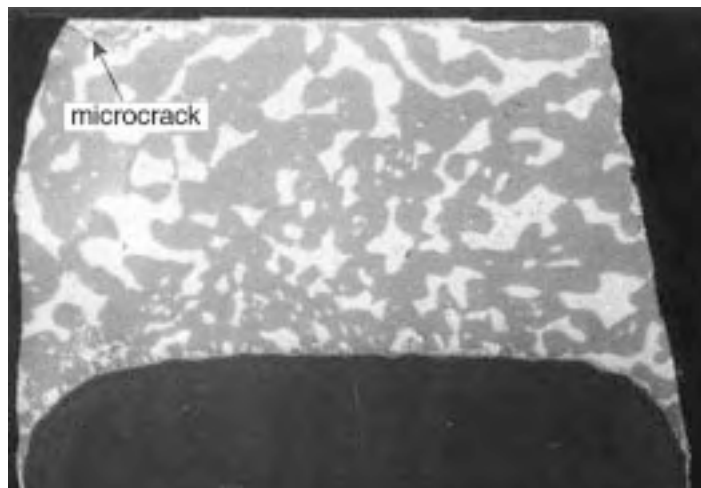
Figure 3: Crack initiation visible in a cross-sectioned solder joint where acoustic imaging had indicated crack formation.

For a solder joint in which crack initiation has just begun, you can find some coarsening effects on the microstructure. This coarsening is more pronounced near the interface between the solder joint and the die face at the top of the photo. Finite element simulations in previous studies have shown that coarsening of the microstructure induces strains in the solder. Both coarsening and strain are most prevalent in the area of the bump nearest to the chip face.
