CSP and micro-BGA Process and Damage Assessment with Acoustic Micro Imaging (AMI)

Steven R. Martell and J.E. Semmens

SONOSCAN Inc.

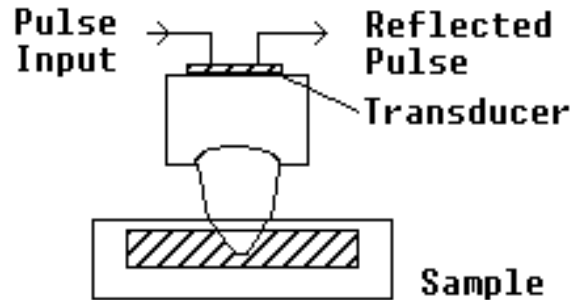
Figure 1. Block Diagram Of The Transducer Section Of A Reflection Mode AMI System.

All reflection mode based AMI systems start off with one basic piece of AMI information called the A-Scan. The A-Scan is obtained by sending a pulse of acoustic energy from a transducer and into the sample under investigation at a specific X-Y location and then looking for the return of any echoes, see Figure 1. Depending upon the construction of the sample/part, there can be multiple echoes or a single echo from the backside, assuming a solid, defect free material. The returned echoes make up the A-Scan and are typically displayed on an oscilloscope.

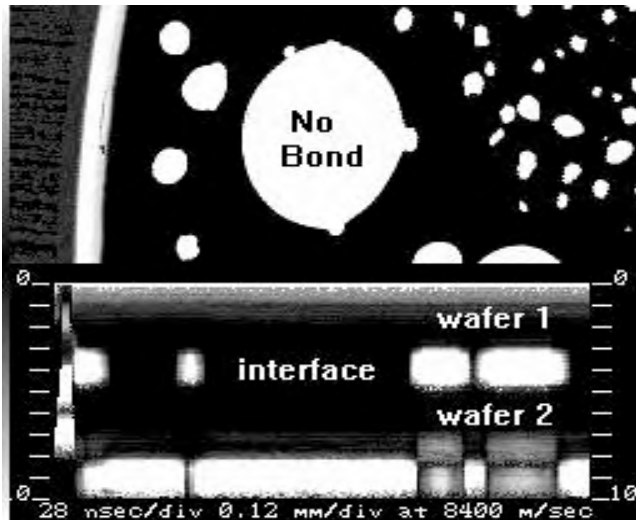
Figure 2. C-Mode Image (Top portion) And Non-destructive Cross Section Called Q-BAM™ (Bottom Portion) Of Two Wafers With Bonded And Non-Bonded Areas.

If the polarity is positive, we know that the first material has a lower acoustic impedance than the second material. If the polarity is negative, we know the first material has a higher acoustic impedance than the second. A simple example would be two silicon wafers bonded together, see Figure 2.

Two properly bonded silicon wafers would not have any reflection from the interface, since they are the same materials, most of the energy is transmitted to the second silicon wafer. If the first wafer is not bonded to the second, some gap exists, which could contain air or be a vacuum.

In either case, most of the energy would be reflected back and would have a negative polarity. It would be negative since silicon has a high acoustic impedance and air/vacuum is low, practically zero.

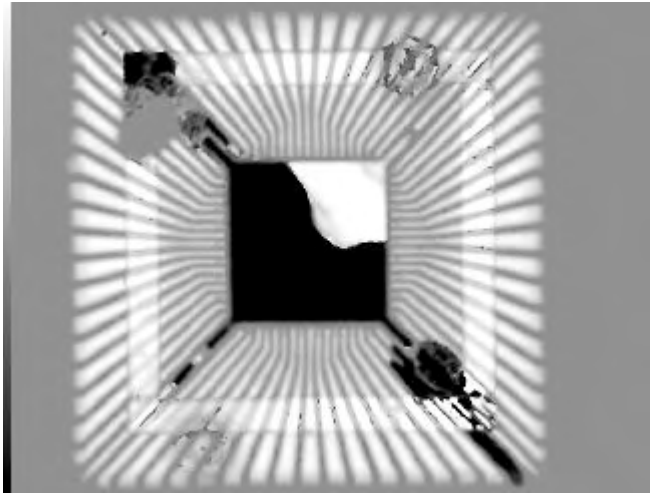
Figure 4. Peripherally Leaded Component With Delamination (Black) On The Paddle And Along The Lead Frame And Support Strip.

One of the unique defects associated with peripherally leaded devices is the delamination between a polymeric film, such as polyimide, and either the molding compound or lead fingers, see Figure 4. The polymeric film support strip used for holding and maintaining the separation between lead fingers in not needed for BGA style packages, where the lead traces are either screened on to the substrate or integrated within the layers.

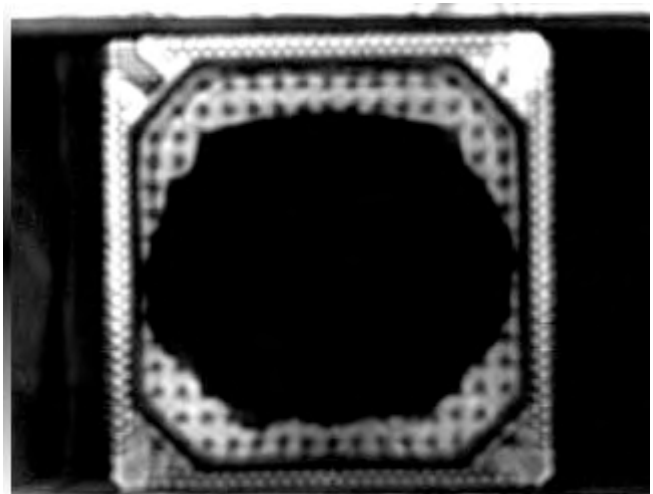
Figure 5. Popcorn Crack Within PBGA (Through Transmission Image).

In addition to the common concerns associated with peripherally leaded devices, there are unique defect types associated with the mold compound to laminate interface, with the laminate itself and the underfill, if present. The most obvious is any delamination between the mold compound and the laminate, which could lead directly to cracks within the laminate, since the weakest bond interface is the fiberglass and the resin, see Figures 5 and 6.

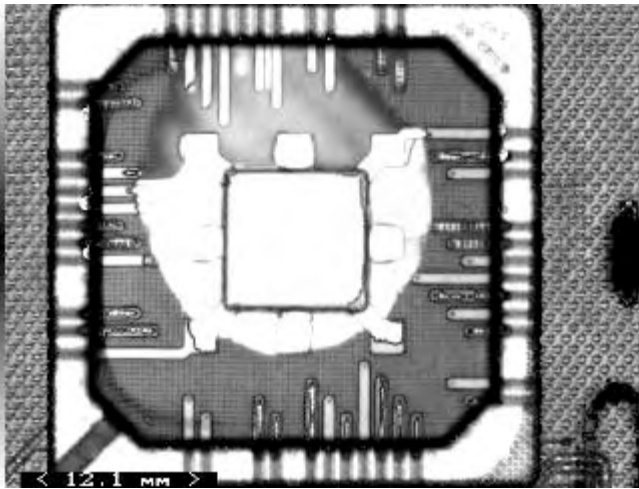
Figure 6. C-Mode Image Of Popcorn Crack Within PBGA Showing Delamination (White) Along Some Traces And Between MC And Laminate. A Crack Within The Laminate Is Observed Near The Top (Gray).

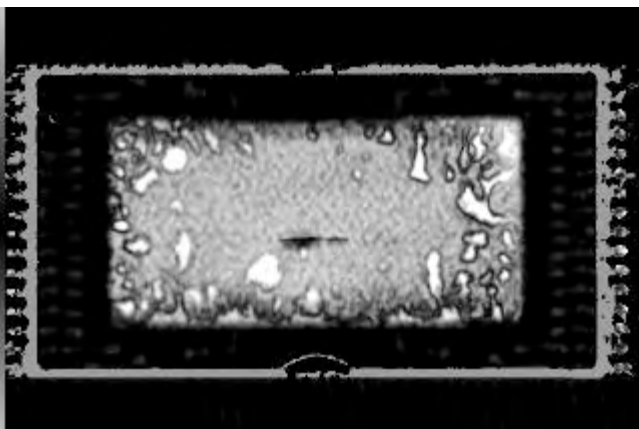
Figure 7. C-Mode Image of TSOP Device With Voids In The Die Attach (White) And Crack In The Die (Black Line Near Center).

While not specifically covered in any of the standards, voids (large delaminations) and die cracks (see Figure 7) need to be looked at closely. Not only are they a potential reliability problem, their mere existence can be an indicator of a problem in the manufacturing process. The problem may not be significant now, but could grow out of hand over time.

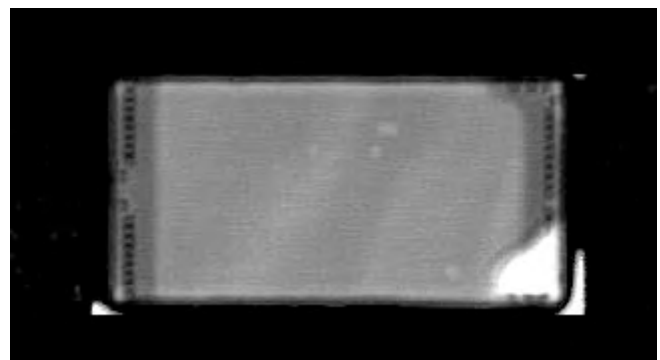
Figure 9. C-Mode Image Of Flex Circuit CSP With Delamination (White) Between the Die and The Elastomer In The Bottom Right Corner.

Defects of concern include any direct disconnections of the circuitry, such as poor solder bump bonds, trace or via breaks in the flex circuit, poor TAB or wire bonds, wire breaks and cratering under the bond pads. Indirect defects that may cause failure on a longer term basis include, voids or cracks in the elastomer material or the mold compound, when overmolded. Due to the mounting process, environmental and/or operating conditions, these benign defects may become deadly. See Figures 9 and 10.

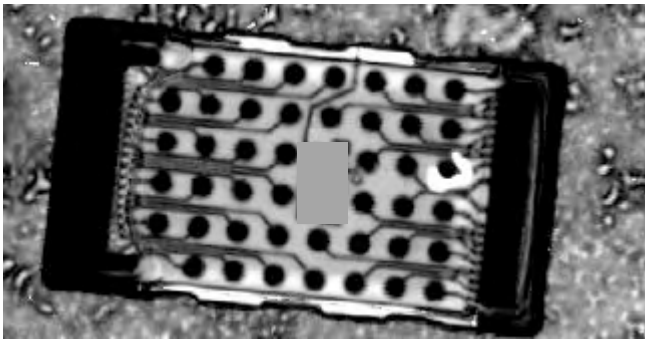
Figure 10. C-Mode Image Showing A Delamination (White) Between The Flex Circuit And The Elastomer.

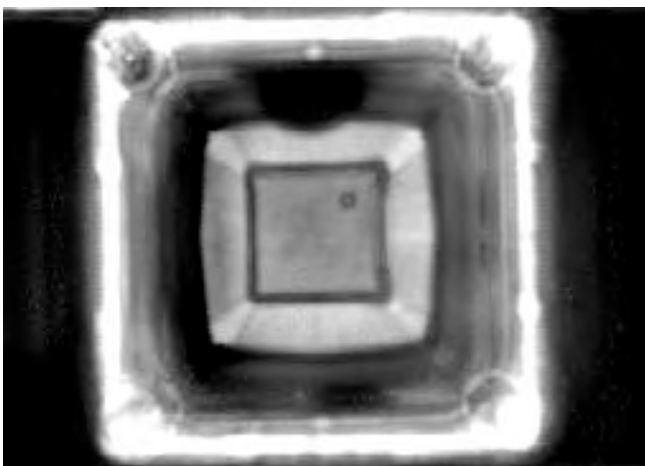
Figure 12. Micro-BGA With Delamination (Black) Within It Observed With Through Transmission.

Similar defects of concern are present for these types of packages as for the flex circuit types. There is the addition of multi layer substrate, which due to its resin/glass construction is more vulnerable to internal defects than the flex circuit materials, in most cases, see Figures 12 and 13.

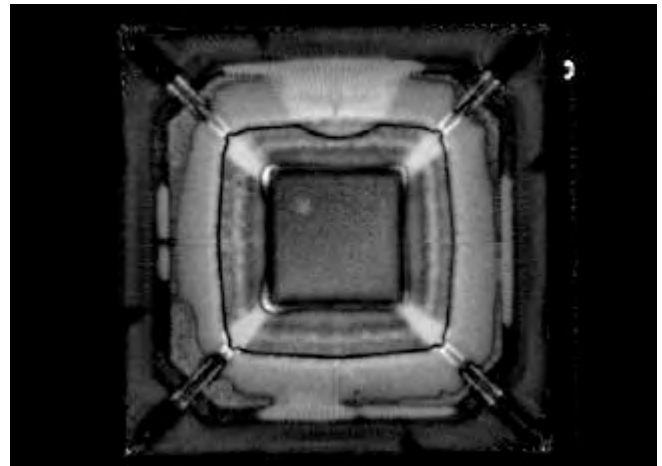
Figure 13. C-Mode Image Of Same Micro-BGA With Delamination And Small Void In The Die Attach.

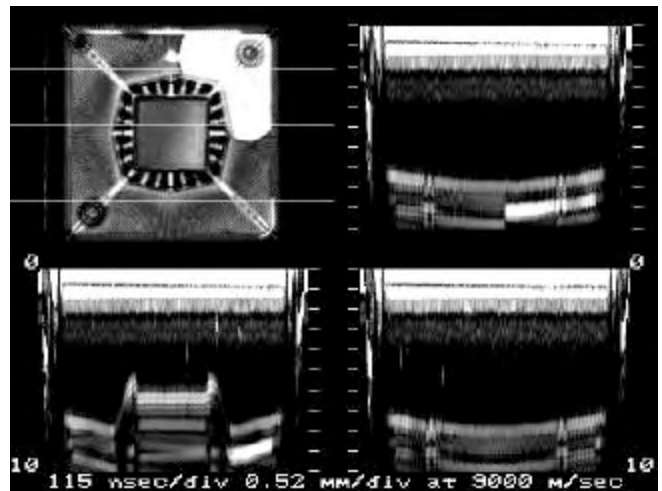
Figure 15. C-Mode (Upper Left) And Multiple Q-BAM™ Images Of Lead Frame CSP With Delamination (White).

Again, defects considered detrimental to the larger packages should be considered more critical, since there is little material beyond the die. In addition, cracks or delaminations between the die and the lead frame should be seriously evaluated, see Figure 15.

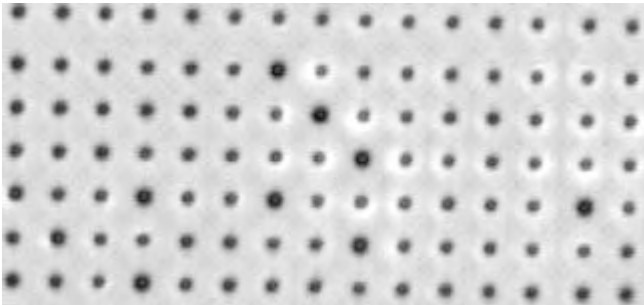
Figure 17. C-Mode Image Of A Mounted Flip Chip With Non-uniform Solder Interconnections.

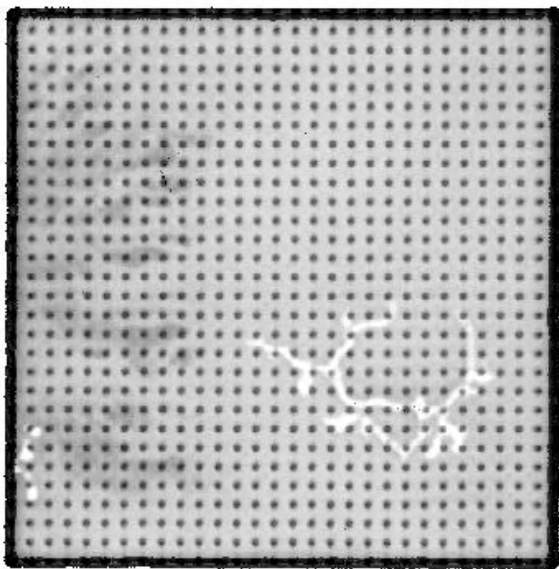
Figure 18. C-Mode Image Of Flip Chip With Voids (White) In The Underfill.

The underfill materials may be applied pre or post interconnect. In either case, the worst indirect defects are voids touching the interconnects, see Figure 18. Without support, the interconnects have a tendency to become unreliable over time. Cracks, delaminations and voids in high stress areas, typically at the corners should also be seriously evaluated, depending on the intended use of the CSP.
